Manhole Inspection Summary

Manhole # S43E__036MH

Insp Date: **4/23/08 9:06 AM**

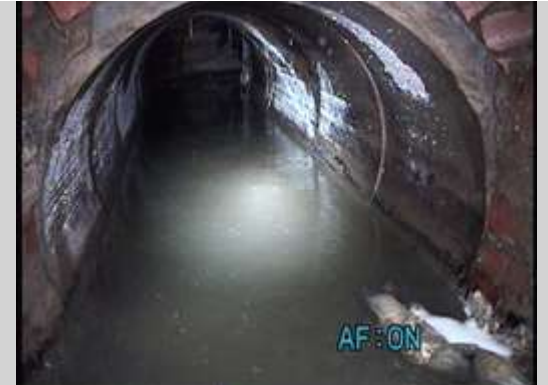
12 O'Clock Outflow

24 in. Circular Gravity Sewer
Pipe Out @ 12 O'Clock

Pipe Height: **24** (in.) Rod and Bar (Angled)
Pipe Material: **Clay** ☐ Pipe Lined
Invert Depth: **19.90** (ft.) Flow Characteristics: **Fast**
Deposits: ☒ None ☐ Mud ☐ Sludge ☐ Debris ☐ Grease
Silt Depth: (in.) Deposits Extent:
Infiltration: **None** Pipe Seal Cond: **Sound**

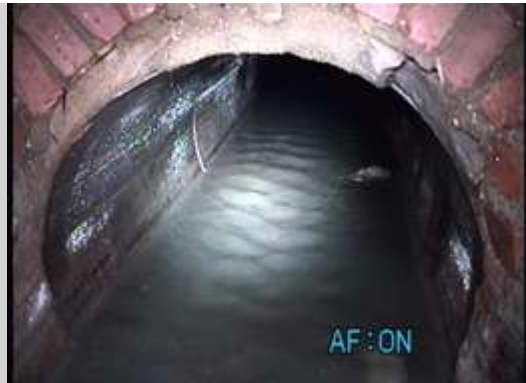
Pipe In @ 9 O'Clock

18 in. Circular Gravity Sewer

Pipe Height: **18** (in.) Rod and Bar (Angled)

Infiltration: **None** Pipe Seal Cond: **Sound**
